Performance Evaluation of Technical Aspects of Ex-Situ Rain Water Harvesting Systems at Wag-Lasta, Northern Ethiopia.

Abstract

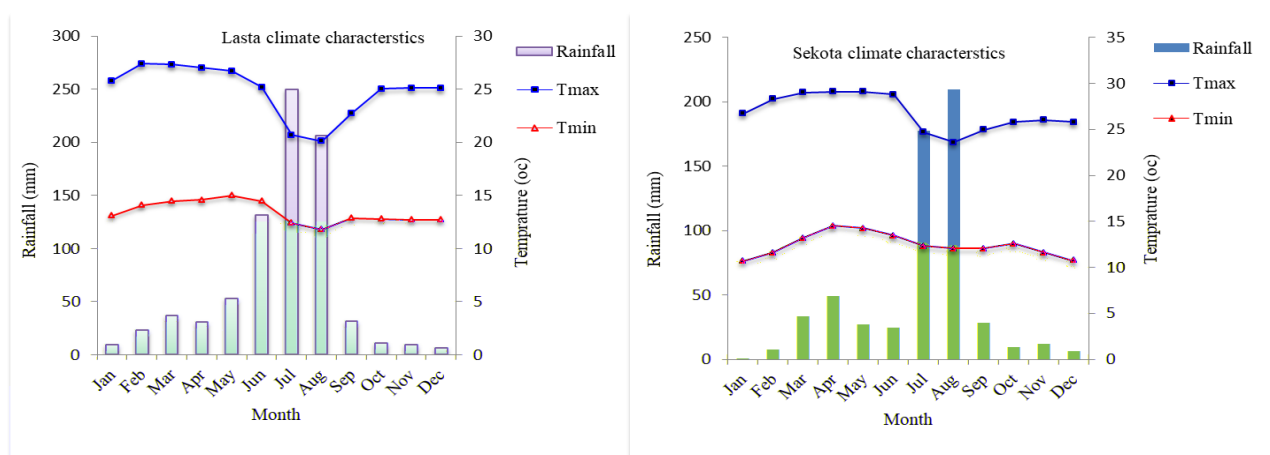
Figure 1. Climate characteristics of the study site

september. The mean annual long-term rainfall in the study areas at Sekota and Lasta was 585.8 mm and 799.3 mm and both characterized with irregular and inconsistent in distribution (Fig.1). The mean minimum and maximum long-term temperature was 12.4 & 26.8 °c at Sekota and 13.4 & 24.8 °c at Lasta woreda respectively (Fig.1). The area is intensively cultivated and the production is subsistence farming. Rain-fed agriculture is the main practice in the study area. However, with the introduction of water harvesting structures like ponds, supplementary irrigation practices were performed. The main crops grown in the study area are sorghum, teff, wheat, barley, faba beans, garlic, potato, tomato, onion, pepper, cabbage and shallots.

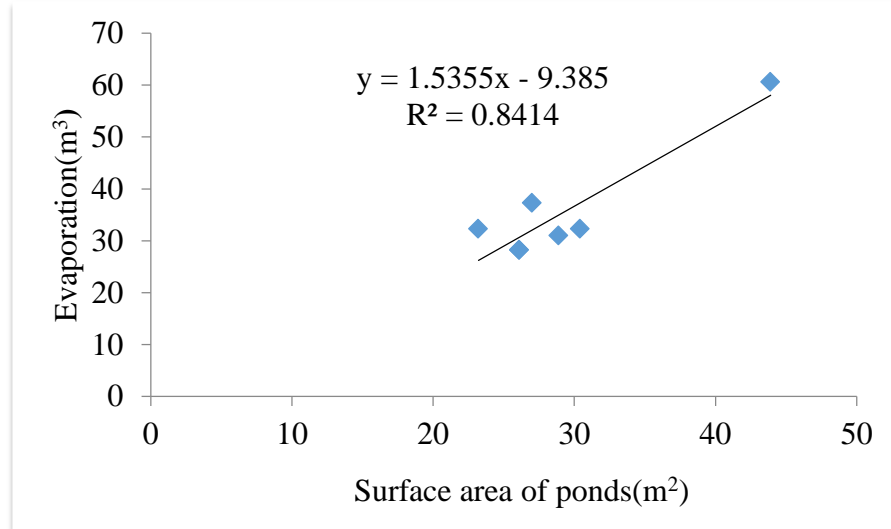
Figure 4. The relation between the pond surface area and the loss of evaporation

The magnitude of the loss from evaporation was usually related to the rainwater harvesting ponds' surface area. The net collected water was used for irrigation in the study areas and other purposes after the rainy season. Vegetables such as cabbage, onion, and pepper were crops grown by most households. During the growing period, the respective gross irrigation requirement was around 465.6, 525.6 & 745 mm at the Sekota site and 422, 469.5 & 650.9 mm at the Lasta site for optimum yield of cabbage, onion, and pepper in that order.

Pond Water Balance: The water balance results during July to December showed that the average irrigation and other consumption were 22.82 and 13.74 m³ respectively (Table 9). The consumption represented 34.5 percent of the total average water collected. The owner of pond P6 used the stored water effectively with the high water productivity of crops because of the water balance, while pond P2 could not use efficiently the completely stored water. Storage of available water in P6 was minimum at the end of December. It is largely due to high use of irrigation. Farmers should produce short growing crops with increasing command area and allow good use of the stored water instead of exposing the stored water to evaporation for a prolonged period.

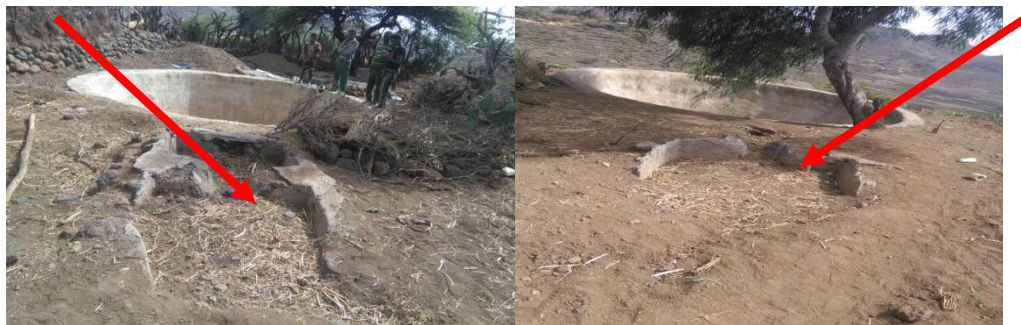
Figure 5. Silt trap full of sediments

The primary reasons for the failure and low performance of rainwater harvesting ponds were unfortunate management and a lack of maintenance. The evaluation found that most of the ponds were inefficient because of inadequate construction and maintenance requirements. More or less rainwater storage ponds were completely silted up and silt traps destroyed. Once the physical construction of the rainwater harvest is in progress, the owner of the pond typically has to take over operation and maintenance. Numerous of the ponds surveyed used below their capacity only after the owner failed to fulfill his obligation.

Sedimentation and evaporation lead to reduce the capacity of ponds. These problems occur in most cases because of non-functional silt traps and inlet structures. On the other hand, the risk of sedimentation was still high, as most of the ponds were not properly constructed. The field observation showed that circular rainwater collection ponds were completely silted up and more or less filled with sediments about the depth of 60-170 cm. Effective management of the catchment and daily maintenance of silt traps and storage ponds may

have avoided sedimentation of the channels before the onset of rain. Absolutely, the ponds did not have evaporation avoidance mechanism at all and therefore water loss was high due to evaporation.
