# Performance of Subsurface Water Drainage Technique on Gully Bank Stability in the Sub-Humid Highlands of Ethiopia

Assefa Derebe\*, Misganew Fentahun, Tilashwork Chanie, Tadele Amare  
Adet Agricultural Research Center, Adet, Ethiopia

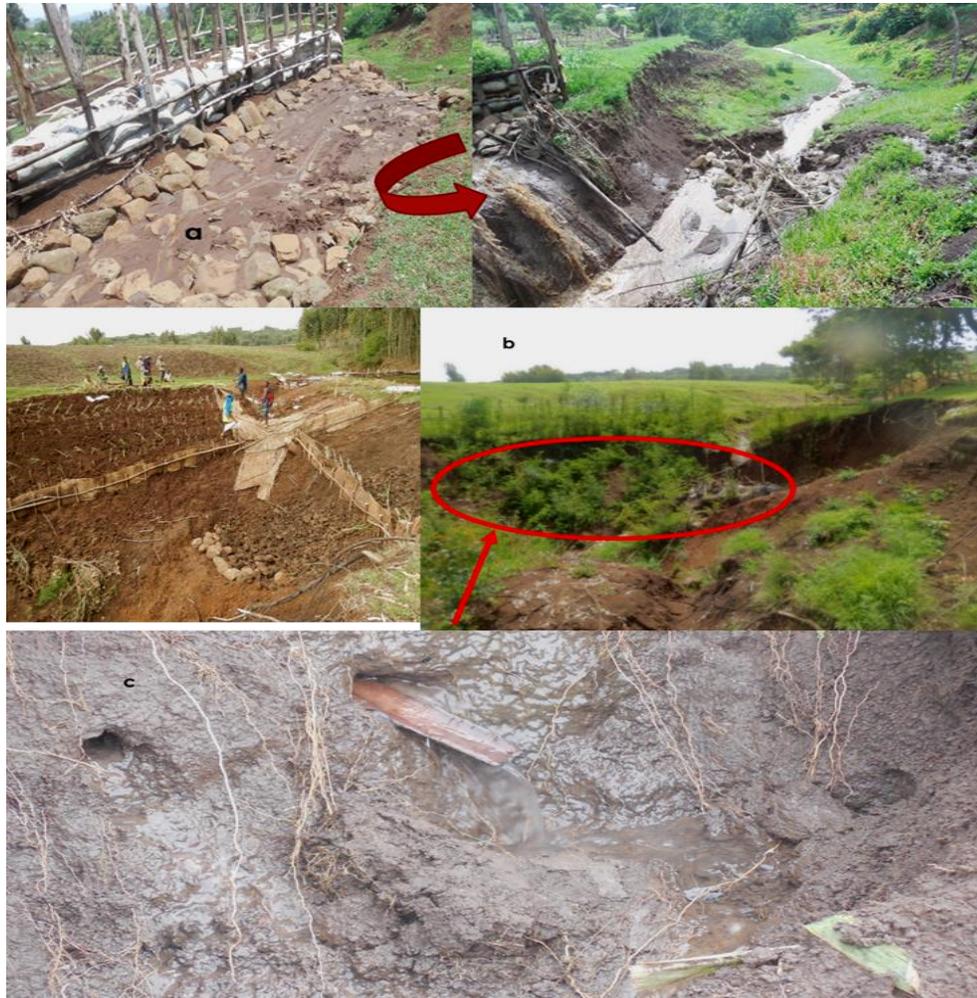
Figure 1. a) Inappropriate diversion of flowing water created another new gully, b) physical and biological headcut treatment by Zegeye *et al.* (2017) and the red circle shows the failure of planted material on the regarded bank due to wet bank, c) natural pipe dewatered the bank water and no failure was observed (Zegeye *et al.*, 2016).

In the case of the study area, Debre Mawi watershed, where gully erosion predominate the bottomlands, previous attempts to stabilize gullies are not very much successful (see Fig. 1b). Diversion of flow initiated new gully (Fig. 1a), vegetation has little effect for gullies up to 6 meters deep (Figure 1b), regrading bank angle and installing checkdams near the headcut significantly reduced the uphill migration of the headcut (Zegeye *et al.*, 2017) but the planted materials started to slide down and this is due to the saturation of the surrounding area of the bank (Fig. 1b). Therefore, stability might be increased by draining subsurface water out of the gully bank mass from within vertical wells or providing passive dewatering through horizontal drains (Shields *et al.*, 2009). From the previous study (Zegeye *et al.*, 2016), one of the monitored gullies was not eroded for two consecutive years and the reason was that the bank was dewatered through the natural pipes along the gully bank (Fig. 1c). Therefore, this research aimed at to evaluate the applicability of a low-cost horizontal drain for stabilizing a rapidly eroding gully bank in the (sub) humid Ethiopian highlands.

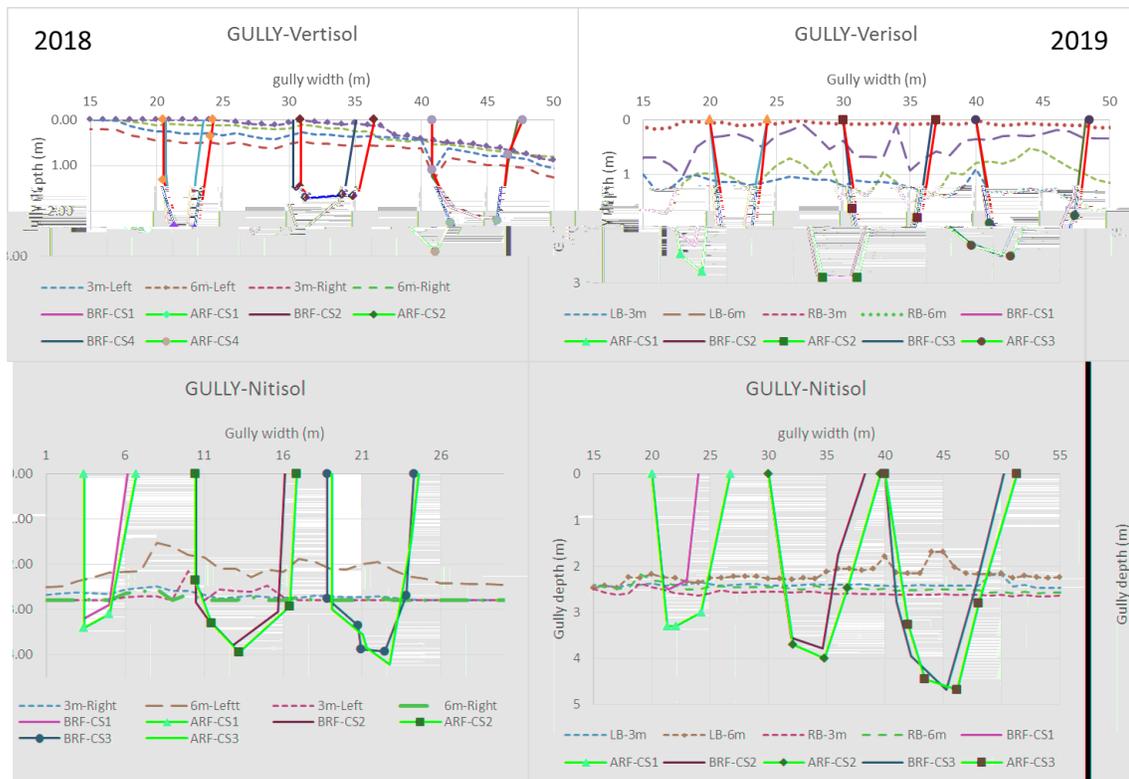
Figure 4. Observed changes in gully geometry and ground water table at 3 m and 6 m from the

As indicated in Fig. 4, piezometers installed near the edge of the gully showed that the water table in these areas was deeper than elsewhere. On the other hand, the water table elevation (Fig. 4) was entirely above the gully bottom, indicating that the gully bank is highly saturated. This lowers the shear strength of the bank material destabilizing the gully banks. As Tebebu *et al.* (2010) and Zegeye *et al.* (2016) reported that saturation is the main cause of gully formation and gully bank sliding. Since the gully bank was saturated (Fig. 4), the pore-water pressure due to rising of ground water elevation has played a key role in triggering gully formation. This result is supported by several authors (e.g., Simon *et al.*, 2008; Tebebu *et al.*, 2010; Langendoen *et al.*, 2013; Zegeye *et al.*, 2016; Zegeye *et al.*, 2020).

In the study gullies, the piezometer readings show that the untreated left gully banks were wetter than the treated (drained) right banks during the testing periods (Table 1, Fig.4). This means that gully banks in which draining pipes were installed were relatively stable as water drains out through the pipes resulting in water table drawdown resulting lower pore-water pressures. In this case, the shear strength of the bank materials increases and reduces bank failure which is in line with the studies of Simon *et al.* (2011) and Zegeye *et al.* (2020).

As observed in Fig. 4, the second cross section of vertisol in 2018 showed that the saturated untreated (control) bank failure debris filled the gully channel that reduced the channel depth until moved by the flowing water downstream. The positive change in cross section area ( $0.6\text{m}^2$ ) was due to the sidewall retreat that compensated the area filled by the bank debris. Generally, the average cumulative bank retreat and soil losses on the drained banks are reduced by 72% and 60% on Vertisol and 74% and 80% on Nitosols, respectively, as compared to the control banks (Table 1). Over the entire period of the experiment, the drained bank lost about  $14\text{ m}^3$  which is 70% less than the control. The results show that dewatered banks retreated about one-fourth as fast as the control. This is because; the pore-water pressure in the drained bank is reduced resulting increase of the shear strength of the bank material which increase stability. This result is supported by Le´onard and Richard (2004) and DeBeats *et al.* (2008) who reported that there was a significant linear relationship between saturated soil shear strength and critical shear stress (defined as the stress at which soil detachment begins or the condition that initiates soil detachment). If the critical stress is higher than the effective stress, the erosion rate is considered zero (Clark and Wynn, 2007).

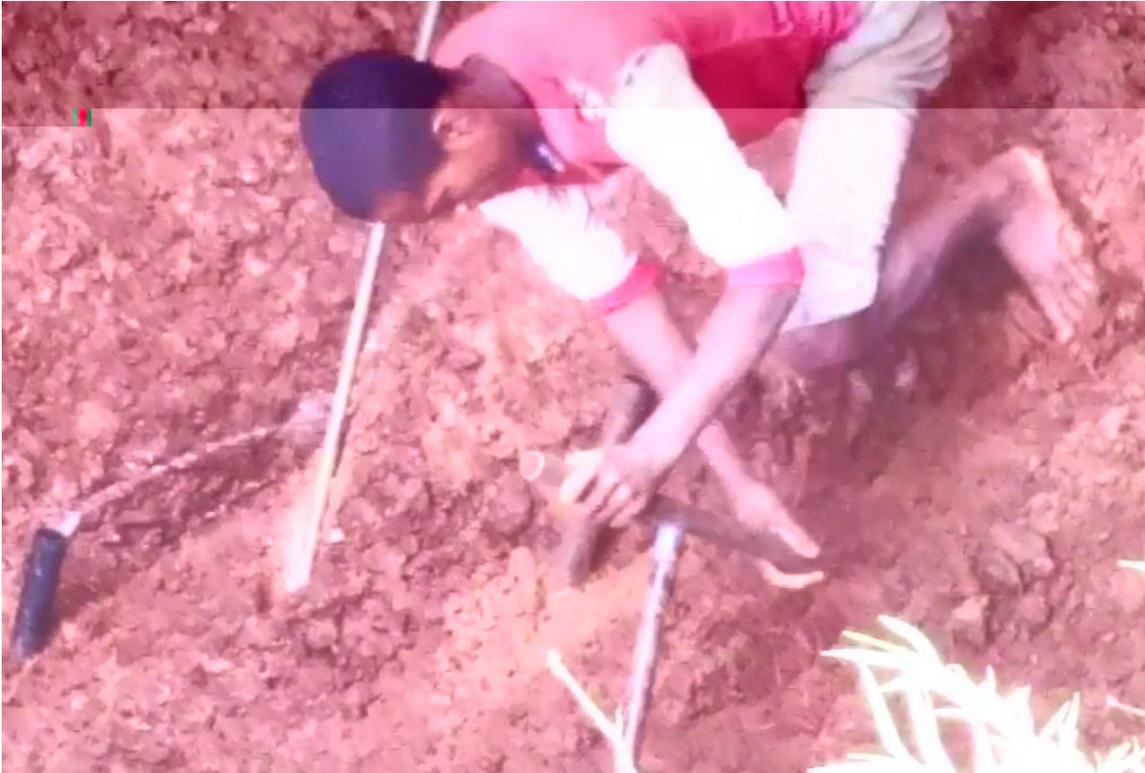
Figure 5. Observed discharges during installing the horizontal drain pipes in Vertisol gully at Debre Mawi watershed (2019). The man is installing pipes using auger of similar diameter.

As shown partially in Fig. 5, the discharge was observed on the five pipes with different amount of which two were in the upper row that were quickly stopped because of the lower row discharges. The upper banks went to dry after two days of installations. Differences in the volume of water discharged among all installed pipes suggest that movement of groundwater through the site was heterogeneous, probably as a result of the lenses of coarser and finer bed material that compose the bank materials and the presence of macropores (Wilson *et al.*, 2007).
